Traditional Walkover Systems Could Not Be Used for an Idaho Project 0

So the HDD Contractor Turned to a Wireline System

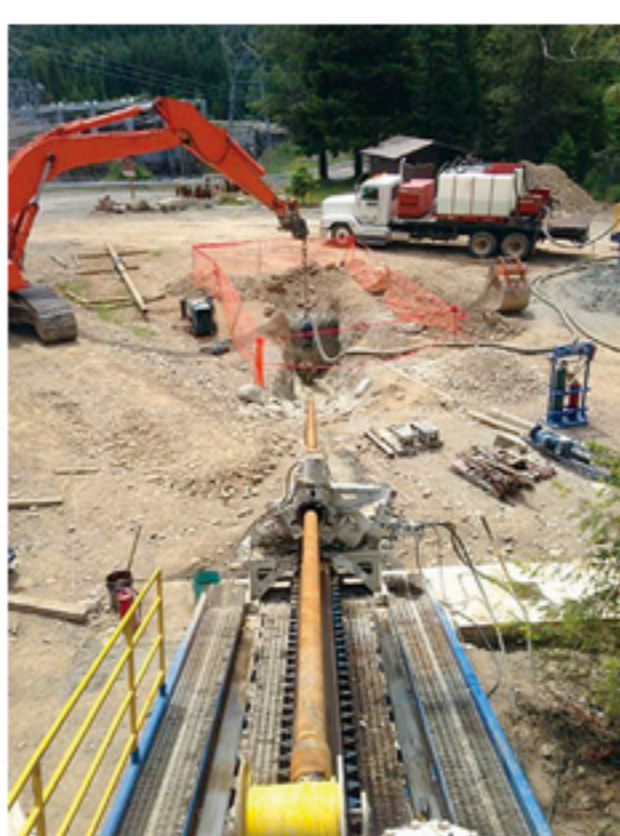
A directional drill rig was mobilized and set up in a small viewpoint parking lot, 140 ft higher than the dam's Power House Roof/Deck. Prime Horizontal used its Paratrack-2 Guidance System and set the coil wire directly on the centerline, with the last 50 ft dropping abruptly down a 100-ft cliff, where the wire took a turn along a catwalk, then down again through an access tunnel and back up to the jobsite.

Because it was impossible for the wire to extend beyond the planned exit point, an AC Beacon would later be set up on the catwalk for completion of the pilot hole. The exit point was on a wall, in a room, another two stories beneath the Power House Deck. To survey the exit point, a total station had to traverse two flights of stairs, a small corridor and eventually shoot into the room itself.

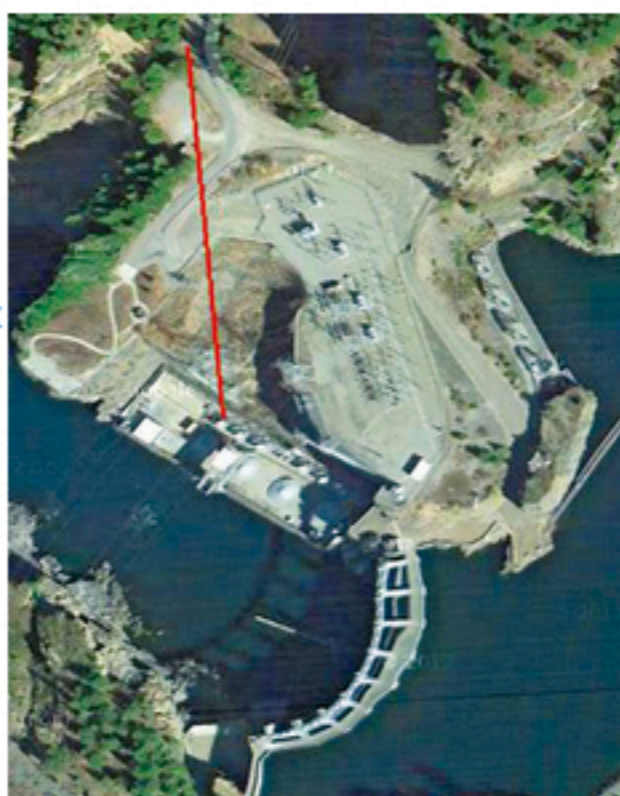
The rig was set up at 20 degrees and the crew dug a well calculated pit to ensure the unguided drill collar would at least start at the correct inclination. When the crew eventually hit bedrock and tripped in the motor assembly, it was determined that the drill collar varied only by 2 degrees in its passage. A slight and very comfortable redesign was made, and the process was smooth from there. Once started, it took three days of drilling to reach the end of the coil wire and the formation reacted predictably the entire way. The crew next set up the beacon and steered the last two rods, stopping short of the 3-ft concrete wall. Over the next few days, the crew prepared the room for the punch out. This meant hanging plastic and setting up pumps and other various containment measures to minimize the mess caused by the hole and drill stem draining into the room.

Finally, the day came. The crew drilled through 2.5 ft of concrete and finally hit a rebar. This caused the last bit of concrete to give way. The room, despite containment efforts, was an absolute mess due to the hole opened in the room. The rest of the day was spent cleaning.
